BAYBERRY FLOODING EVALUATION

**Prepared for:
City of Wyoming
Kent County, Michigan**

**January 20, 2014
Revised April 3, 2014
Project No. G130701**

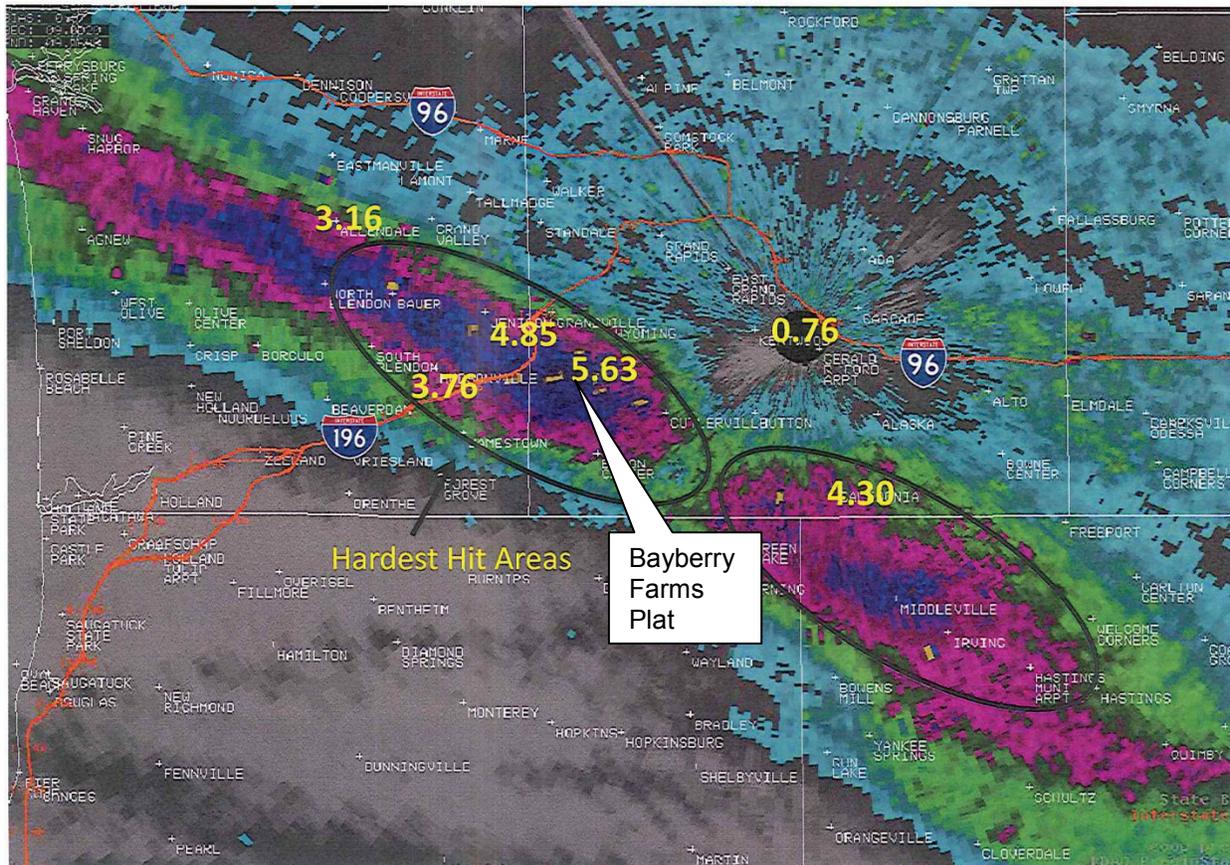
Graphic 1 - Radar Image of Rainfall Depth [in]

The rainfall event of September 9, 2013, can be represented several ways. Graphic 1 shows a radar-based image of total rainfall depth from the Gerald R. Ford Airport. It shows the hardest hit areas follow a fairly narrow band running in a northwest to southeast direction with some of the most extreme values in the City's panhandle area.

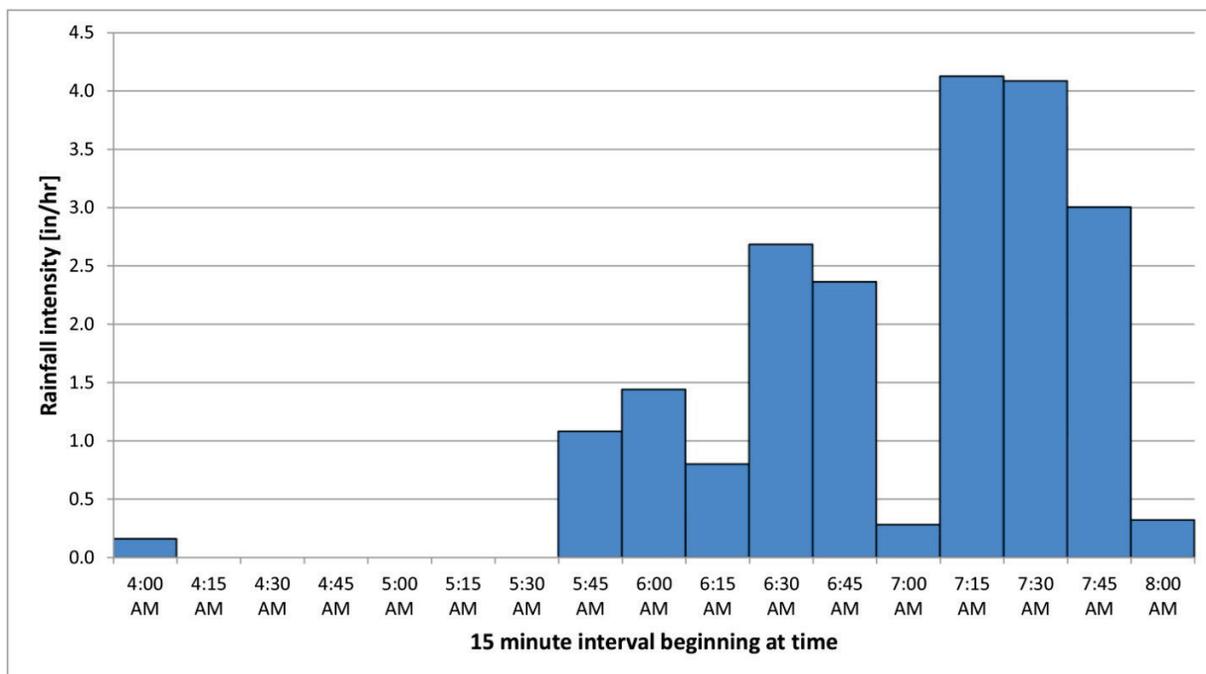
Graphic 2 - Rainfall Hyetograph from Gezon Weather Station

The Gezon pumping station located just east of Byron Center Avenue and Gezon Parkway has a weather station located at the base of the Gezon water tank. This is a much better source of precipitation data since it is only one-half mile from the Bayberry Development and it is based on physical measurement of rainfall (as opposed to radar data). Graphic 2 shows the rainfall hyetograph. This is a plot of rainfall intensity (measured in inches per hour) as a function of time. The total rainfall depth was measured at 5.08 inches, with 5.04 inches falling in the 3-hour period between 5:30 a.m. and 8:30 a.m. During the half-hour period between 7:00 and 7:30 a.m., the intensity was above 4 inches per hour.

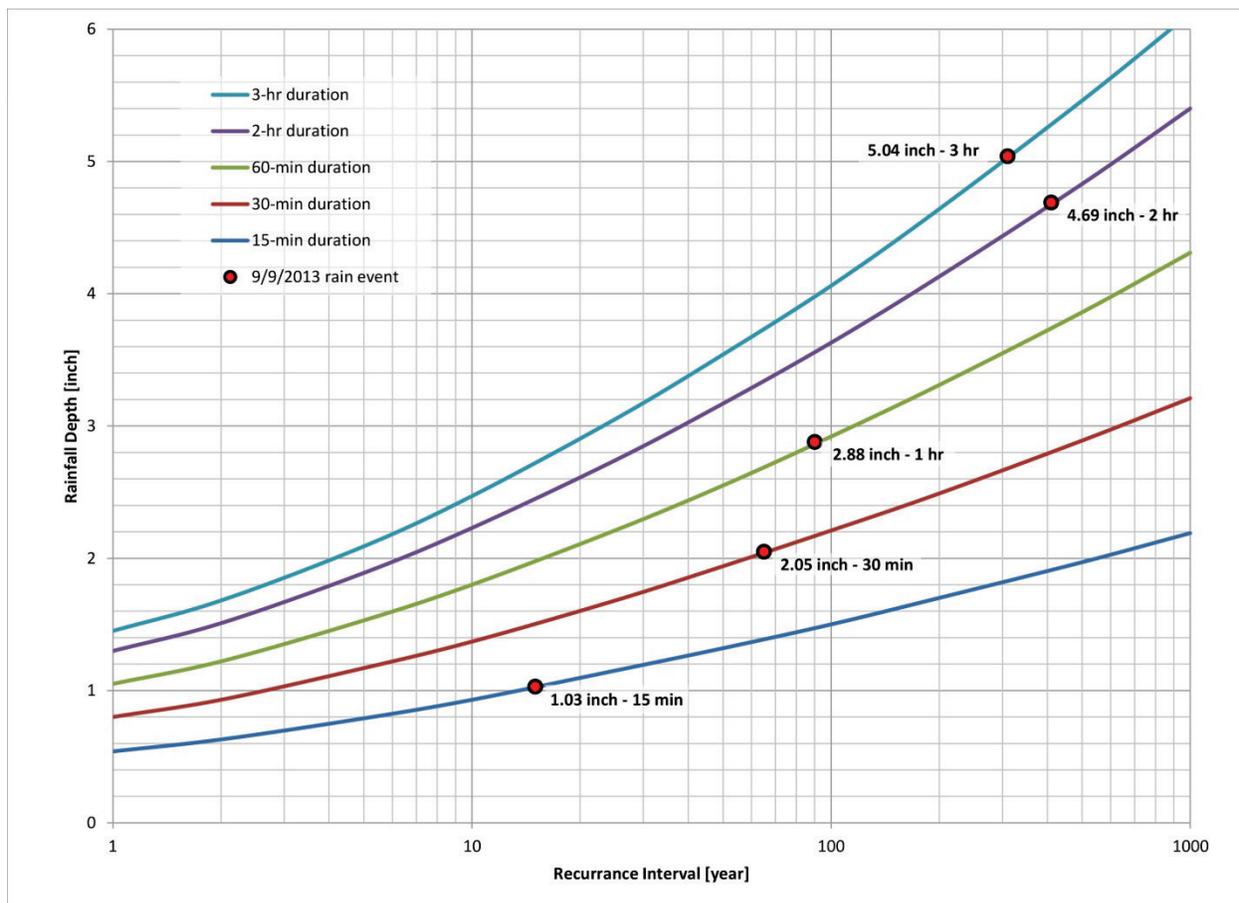
Graphic 3 - Precipitation Frequency Analysis

As discussed previously, rainfall events are normally quantified either in terms of an exceedance probability (percent chance storm) or a recurrence interval. To classify a storm in either manner requires both the rainfall depth and storm duration. In April 2013, the National Oceanographic and Atmospheric Administration (NOAA) released updated precipitation frequency data for Midwestern States including Michigan (Atlas 14, Volume 8, 2013). Graphic 3 compares the September 9 storm to the new NOAA data. The solid lines show the NOAA frequency data for Wyoming, Michigan. The lowest curve is for storms of 15-minute durations, and the upper curve is for storms of 3-hour durations. The data for September 9, 2013, is shown with red markers. The most extreme part of the storm was a two-hour period where 4.69 inches of rain fell. This corresponds to a 400-year rainfall recurrence interval.

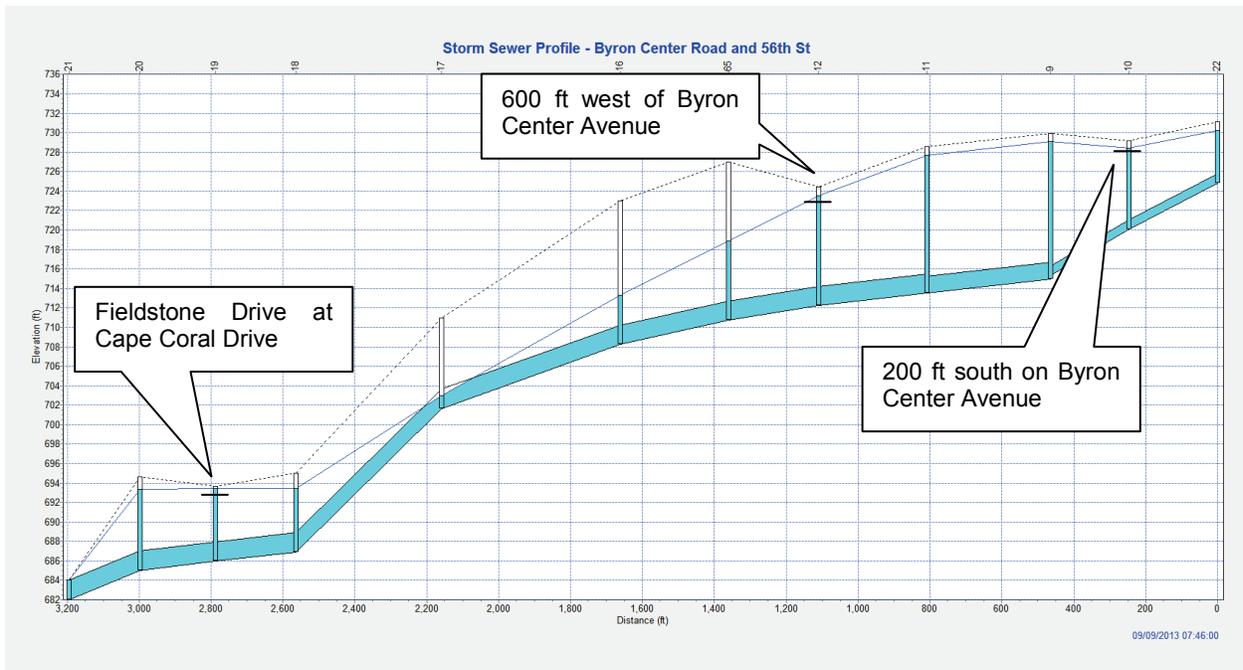
Graphic 4 - Profile of 56th Street and North Byron Center Avenue Storm Sewer (09/09/2013)

The upper two runs of 12-inch pipe are located in Byron Center Avenue. In this profile, the dashed ground surface line is shown 1 foot above the actual top-of-road due to the modeling of overland flow. Top-of-road elevations are shown by the black line at critical locations.

The profile shows the storm sewer system is taxed during an extreme rain event except through the reach of steep pipe west of Bayberry Farms Drive. The sag curves in the roadway tend to pond the water that surcharges from the catch basins or reaches these locations by overland flow.

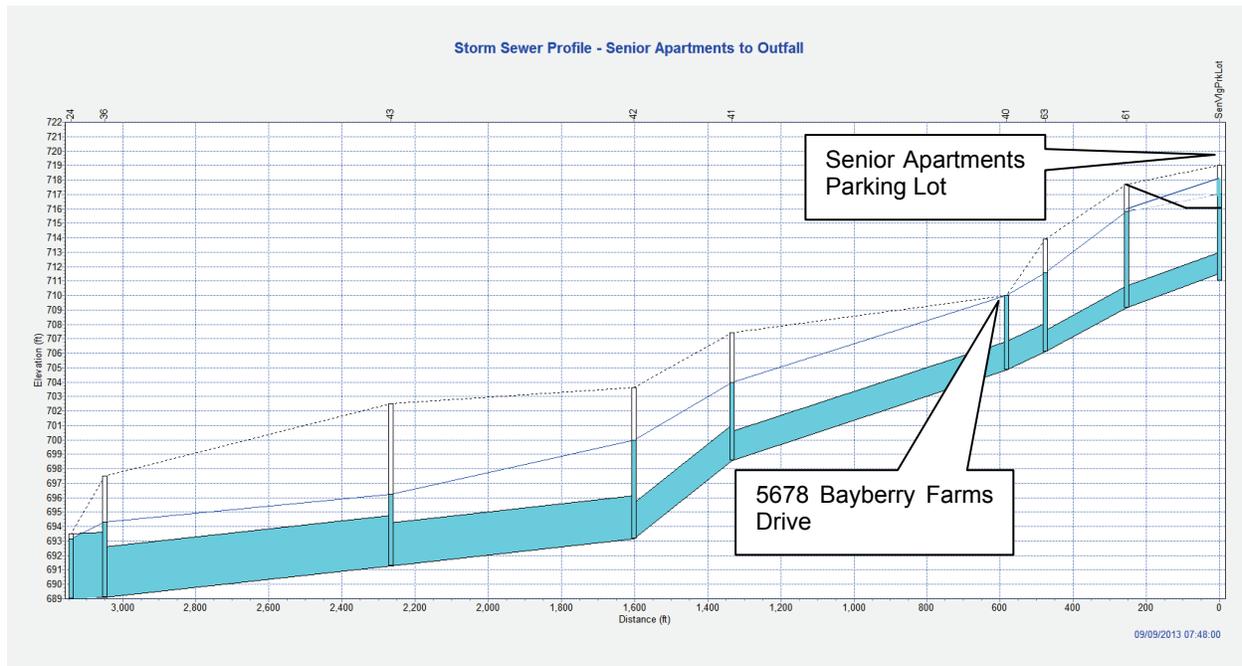
Graphic 5 - Profile of Barcroft Drive Storm Sewer (09/09/2013)

Model results shows the storm sewer functions well even for extreme rainfall events. However, the profile plot clearly shows the critical location in the system is the low area east of Bayberry Farms Drive where two homes experienced basement flooding. As-built survey shots show the house at 5678 Bayberry Farms Drive has a first floor elevation of 715.5 feet, which is 2 feet lower than the neighboring houses. The nearest catch basin is 5 feet lower than the finished floor elevation, which means the basement floor is approximately 3.5 feet below the catch basin rim. Minimum building openings for these lots are shown as 706.0 feet in restrictive covenants. However, this elevation does not correspond with existing grades and would set minimum openings 4 to 5 feet below the adjacent ground surface surrounding these lots.

Flooding of the Senior Apartments parking lot is also shown in the profile plot. Since this area was modeled as a storage unit, the dashed line represents the peak storage elevation and not the ground surface. The black line indicates top-of-casting for the lowest catch basin in the Senior Apartments parking lot.

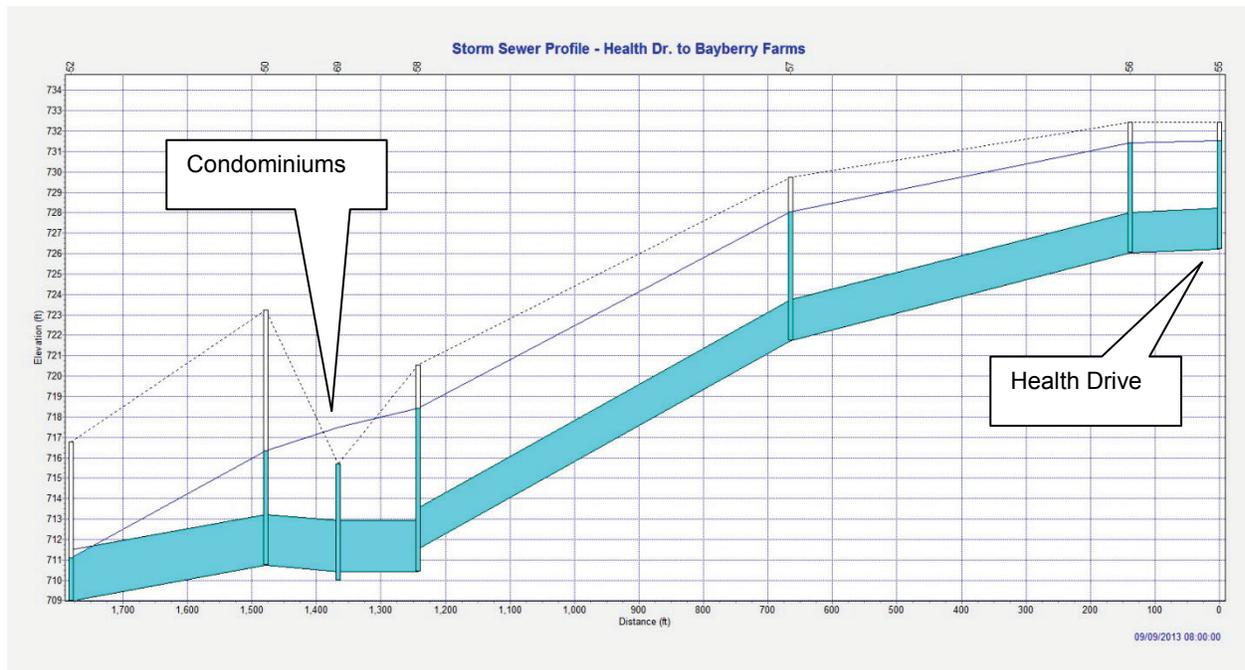
Graphic 6 - Profile of Bayberry Farms Condominiums Storm Sewer (09/09/2013)

The profile shows the susceptibility of the Condominium units to flooding from surcharging of the storm sewer system. The backflow preventers included in the model prevent the storm sewer from discharging water back into the swale behind the Condominium units. The water surface flooding at this location is caused primarily from surface runoff from the immediate drainage area and overland flow from the Bayberry Market detention basin. However, the ability of this water to drain away is dependent on the water elevation in the downstream pipe, so the swale will only drain when the water level in the pipe is below the water level in the swale.

As seen by the water surface below the top of pipe at the left-hand side of this profile, the Bayberry storm sewer has no effect on backwater in the Condominium storm sewer.

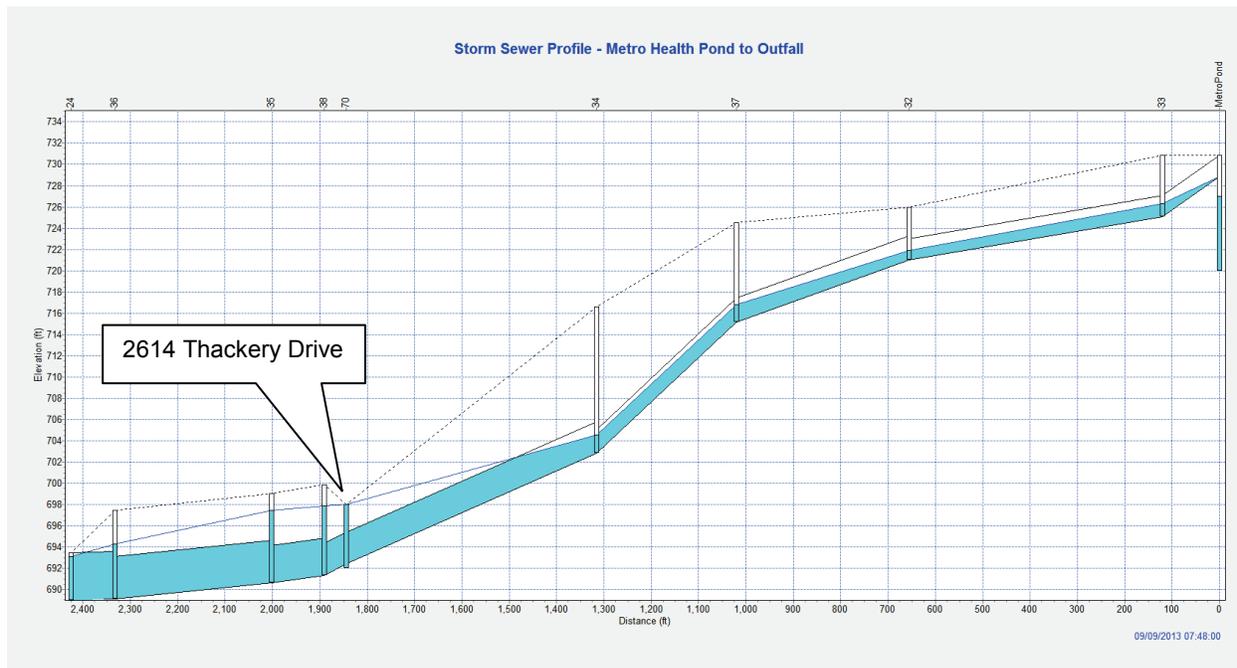
Graphic 7 - Profile of Bayberry Farms Drive Storm Sewer (09/09/2013)

Model results show the storm sewer functions well even for extreme rainfall events. However, the profile plot clearly shows the critical location in the system is the low area south of Thackery Drive. Two trunk sewers also come together at this location in Scarsdale Drive (Figure 2). The effect of this combined flow can be seen by the flattening of the water surface, indicating a backup of water, which floods due to the low topography (Figure 3). As-built survey shots show a low opening sill elevation of 701 feet and a basement floor elevation of 697.3 feet for the residence at 2614 Thackery Drive. GIS shows a storm sewer invert of around 692 feet with a catch basin rim elevation around 698 feet. The minimum building opening elevation required for this lot by restrictive covenant is 701.0 feet, so the structure is in compliance.

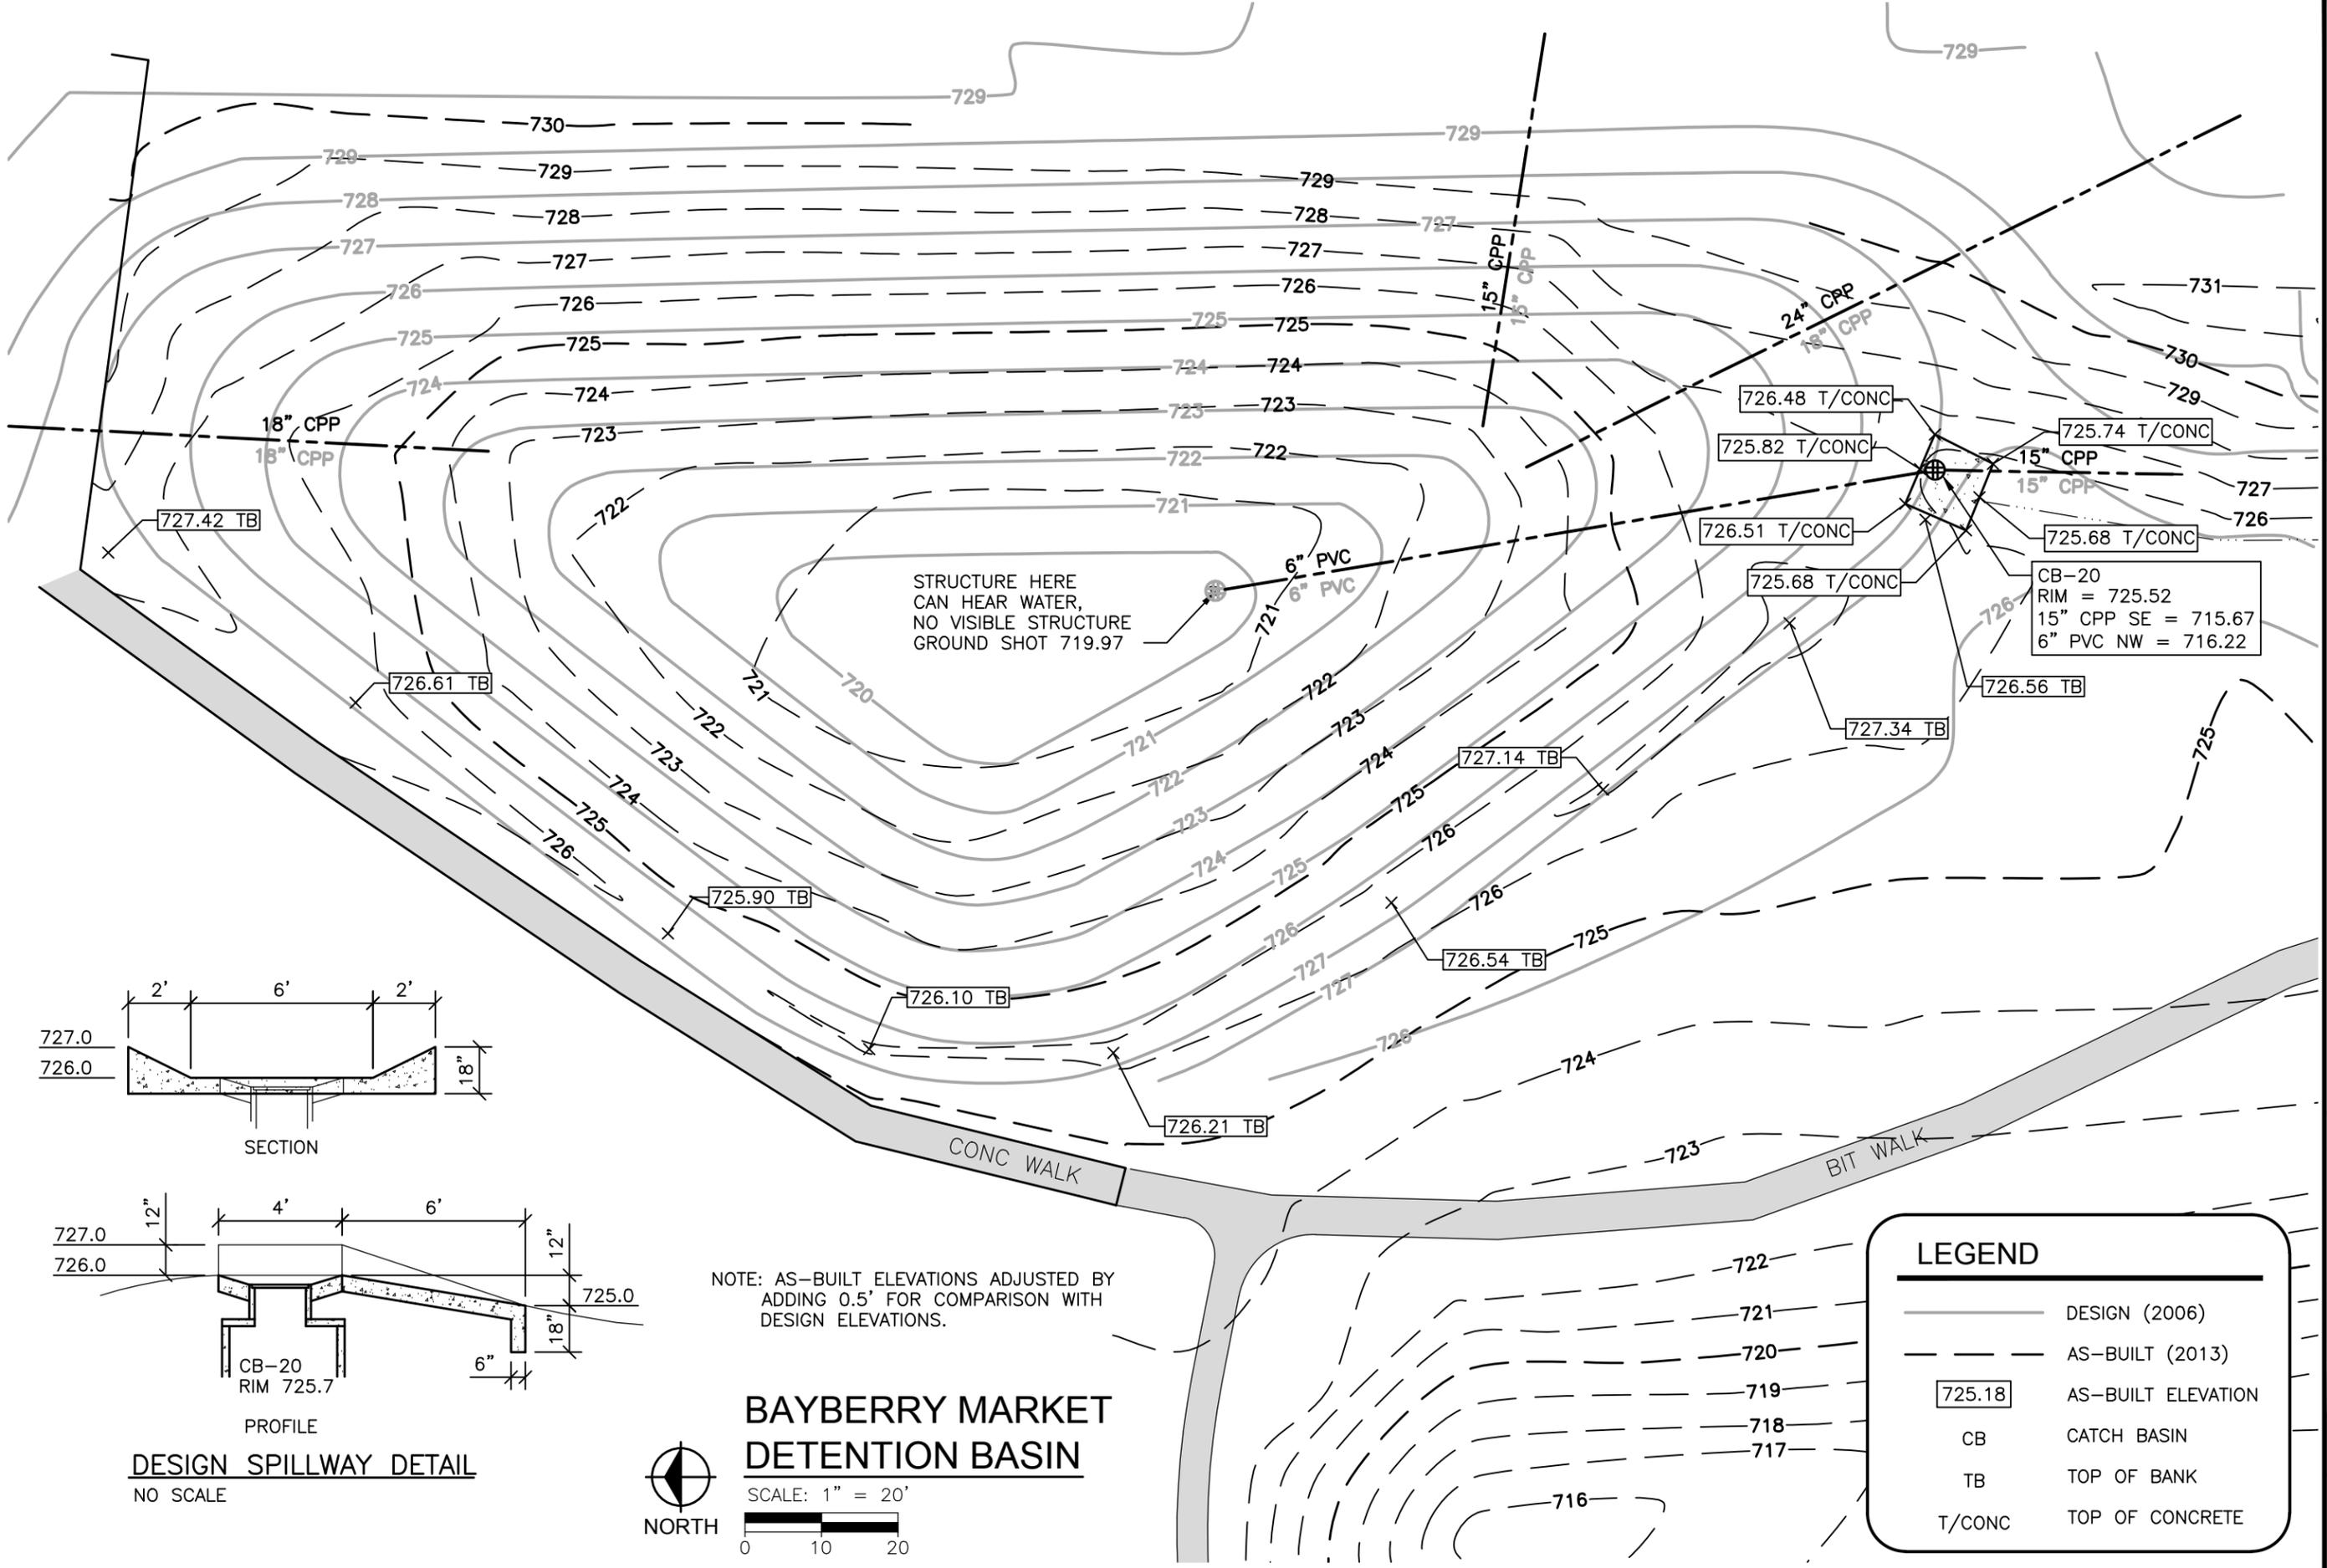
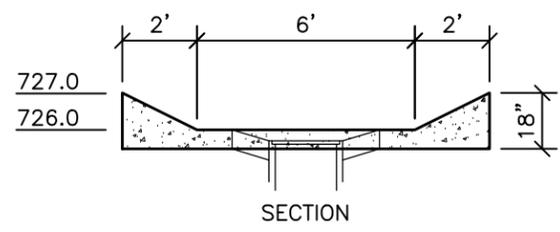
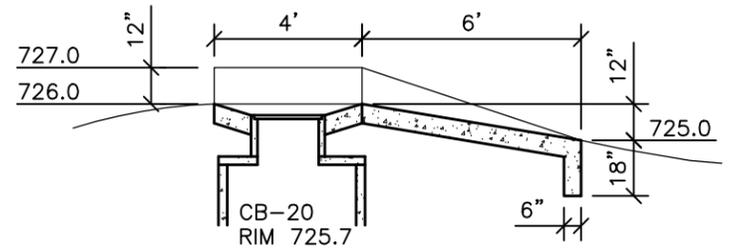
Results of the as-built survey indicate several deficiencies with the existing detention basin. Most notable are the top-of-berm elevations along the west side of the basin, which are at the same elevation as the overflow spillway crest and up to 1 foot lower than the design elevation of 727 feet. This means the basin will overflow to the west at the same time the overflow spillway engages. Water discharged over the top of the detention basin can flow three ways: south along the pedestrian path to the back of the Condominiums and into a swale with a projecting 24-inch reinforced concrete pipe (RCP) inlet, west across an open area and into a catch basin inlet, or north in back of the Senior Apartments and into a catch basin inlet (Figure 3). None of these inlets were designed to take additional water from the detention basin.

The route from the overflow spillway also has some design deficiencies. The overflow spillway was designed to route flows to the south, first through a 15-inch pipe connected to the 30-inch storm sewer system at the Condominiums, and second over the top of the concrete spillway to a grassed swale (upper swale). While the concrete spillway is adequately sized to convey the 10-year peak inflow (18 cfs) into the detention basin in accordance with City standards, the catch basin inlet at the top of the spillway does not have adequate inlet capacity for the design discharge without a large amount of head (ponded water). The catch basin at the top of the spillway was designed only 0.3 feet lower than the

The Bayberry Market detention basin was found to have several deficiencies. The outlet pipe has become buried, which increases the chance of overflow. The basin is undersized for the 25-year design storm. Most importantly, the berm on the west side of the basin is too low and overflows are directed to the Condominiums and Senior Apartments storm sewers, which were not designed for this additional water. Finally, the upper swale downstream of the overflow spillway has only 0.5 foot of depth before cresting and flowing into the lower swale of the Condominiums.

This outlet was found to be buried during the as-built survey. Consideration should also be given to design improvements to prevent the inlet from becoming buried. At a minimum, the developer/property owner should establish an annual maintenance plan that includes a dedicated budget, regular inspections, and a timeframe for required actions and provide a copy to the City. If such a plan already exists, the developer should review the plan for needed updates and proceed to implement regular maintenance.

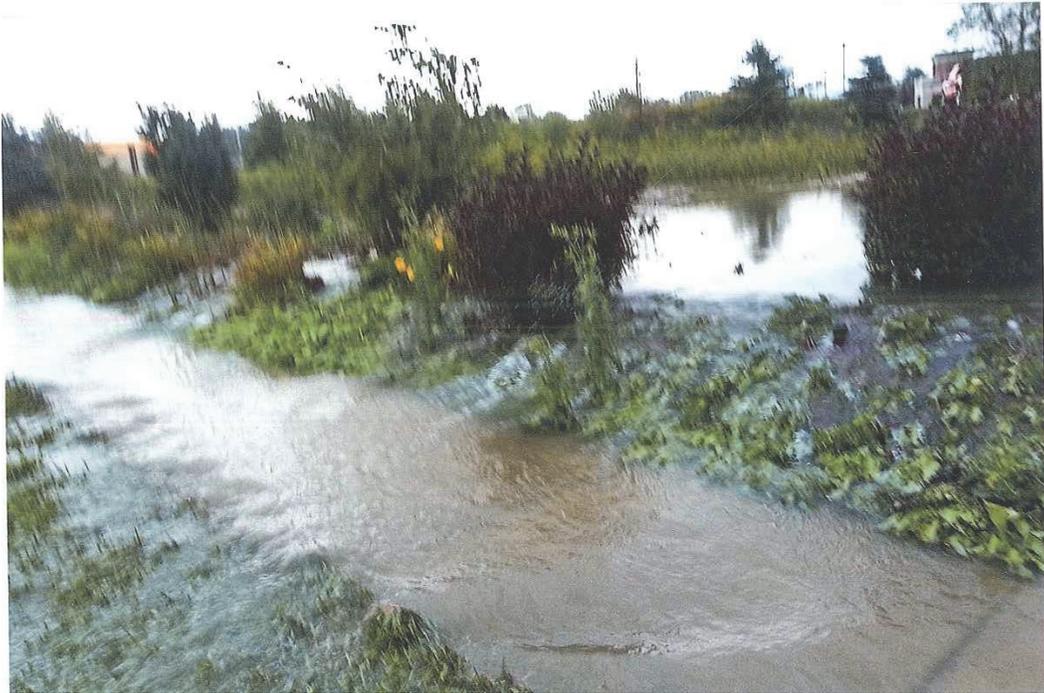
1. Looking northeast at Bayberry Market detention basin.

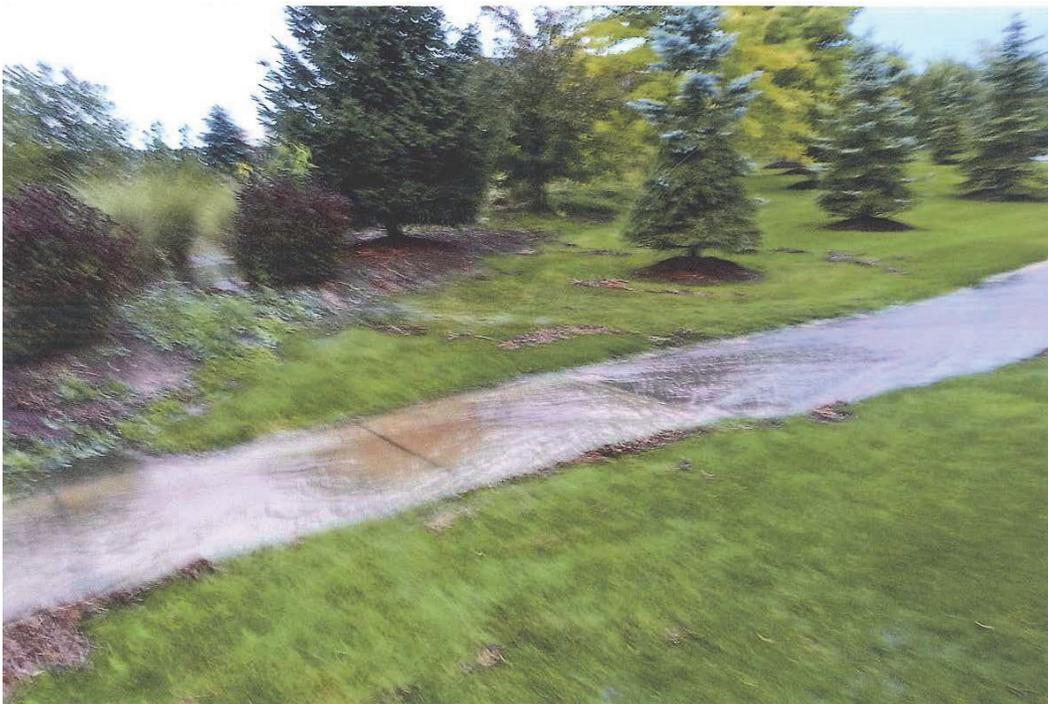
2. Looking southeast at Bayberry Market detention basin.

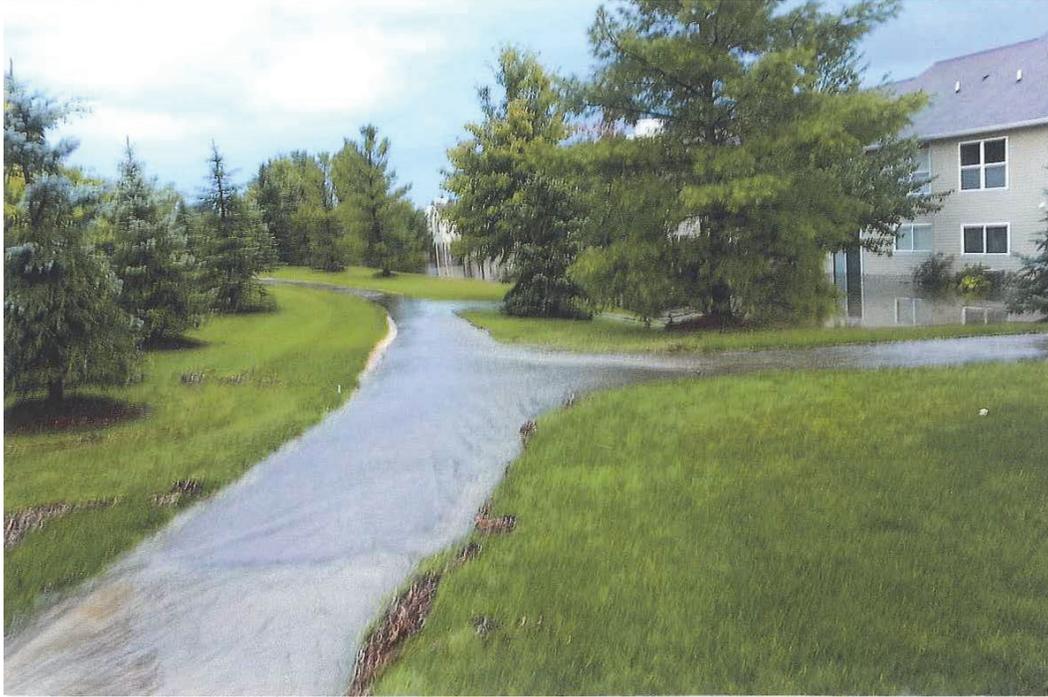
3. Looking south toward condominiums.

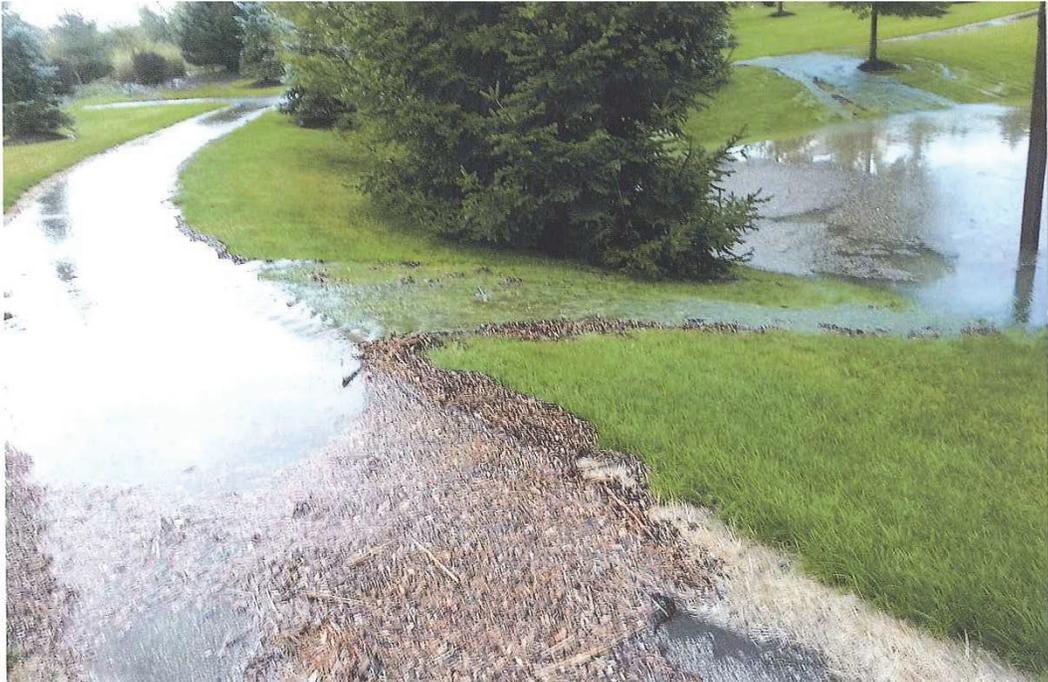
4. Looking south along the walking path at water spilling into the low area in back of condominiums.

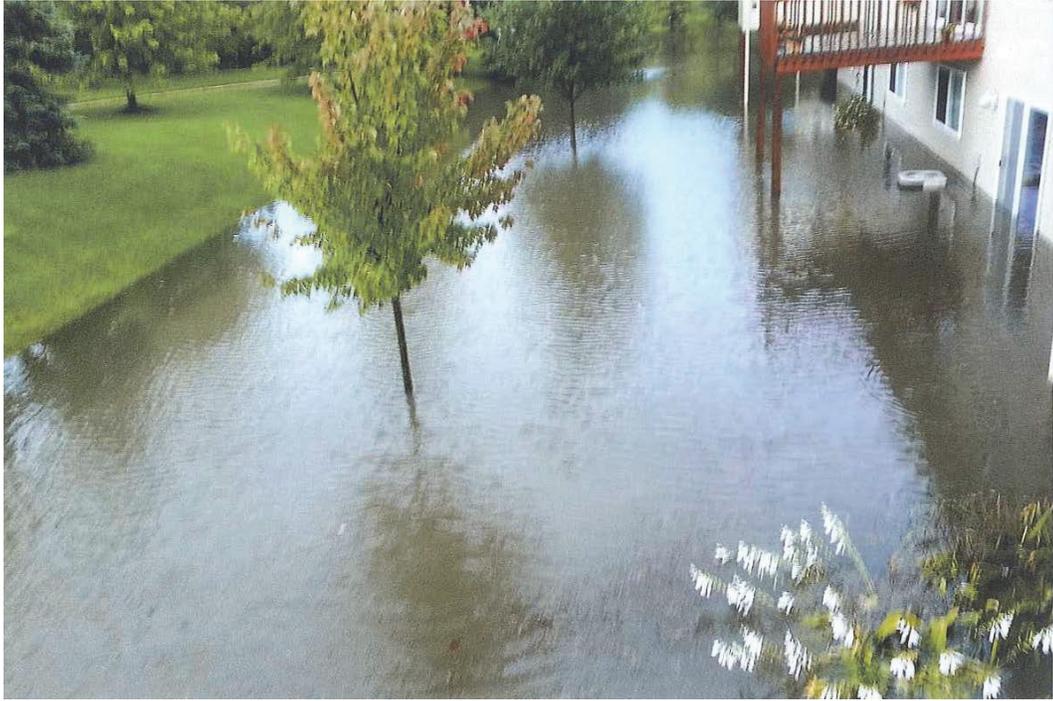
5. Flooding in back of condominiums.

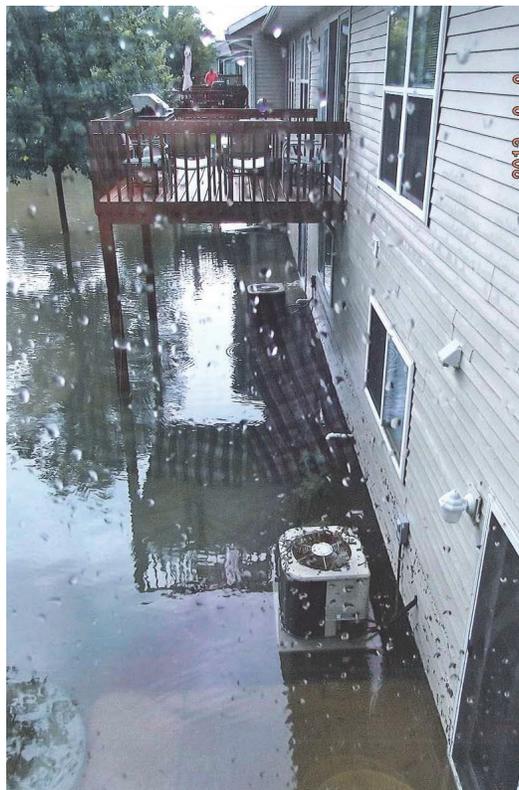
6. Flooding in back of condominiums.

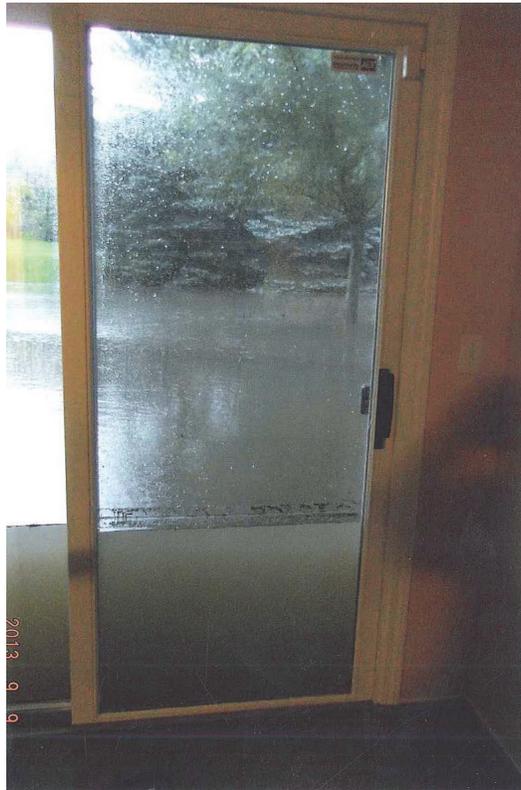
7. Flooding of condominium unit.

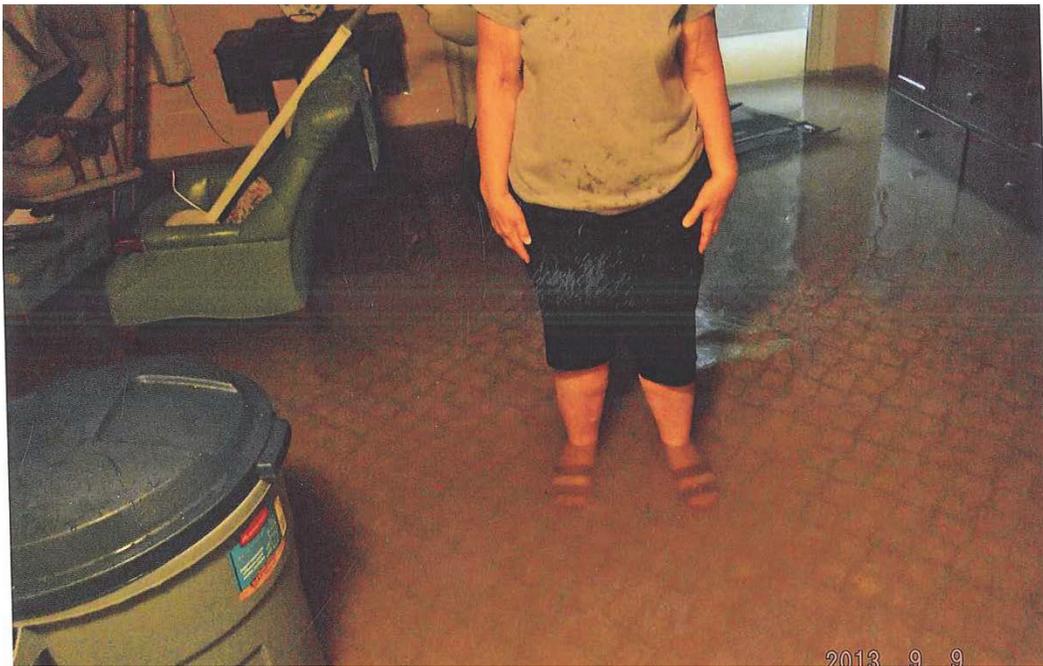
8. Flooding of condominium unit.
