BAYBERRY FLOODING EVALUATION

**Prepared for:
City of Wyoming
Kent County, Michigan**

**January 20, 2014
Revised April 3, 2014
Project No. G130701**

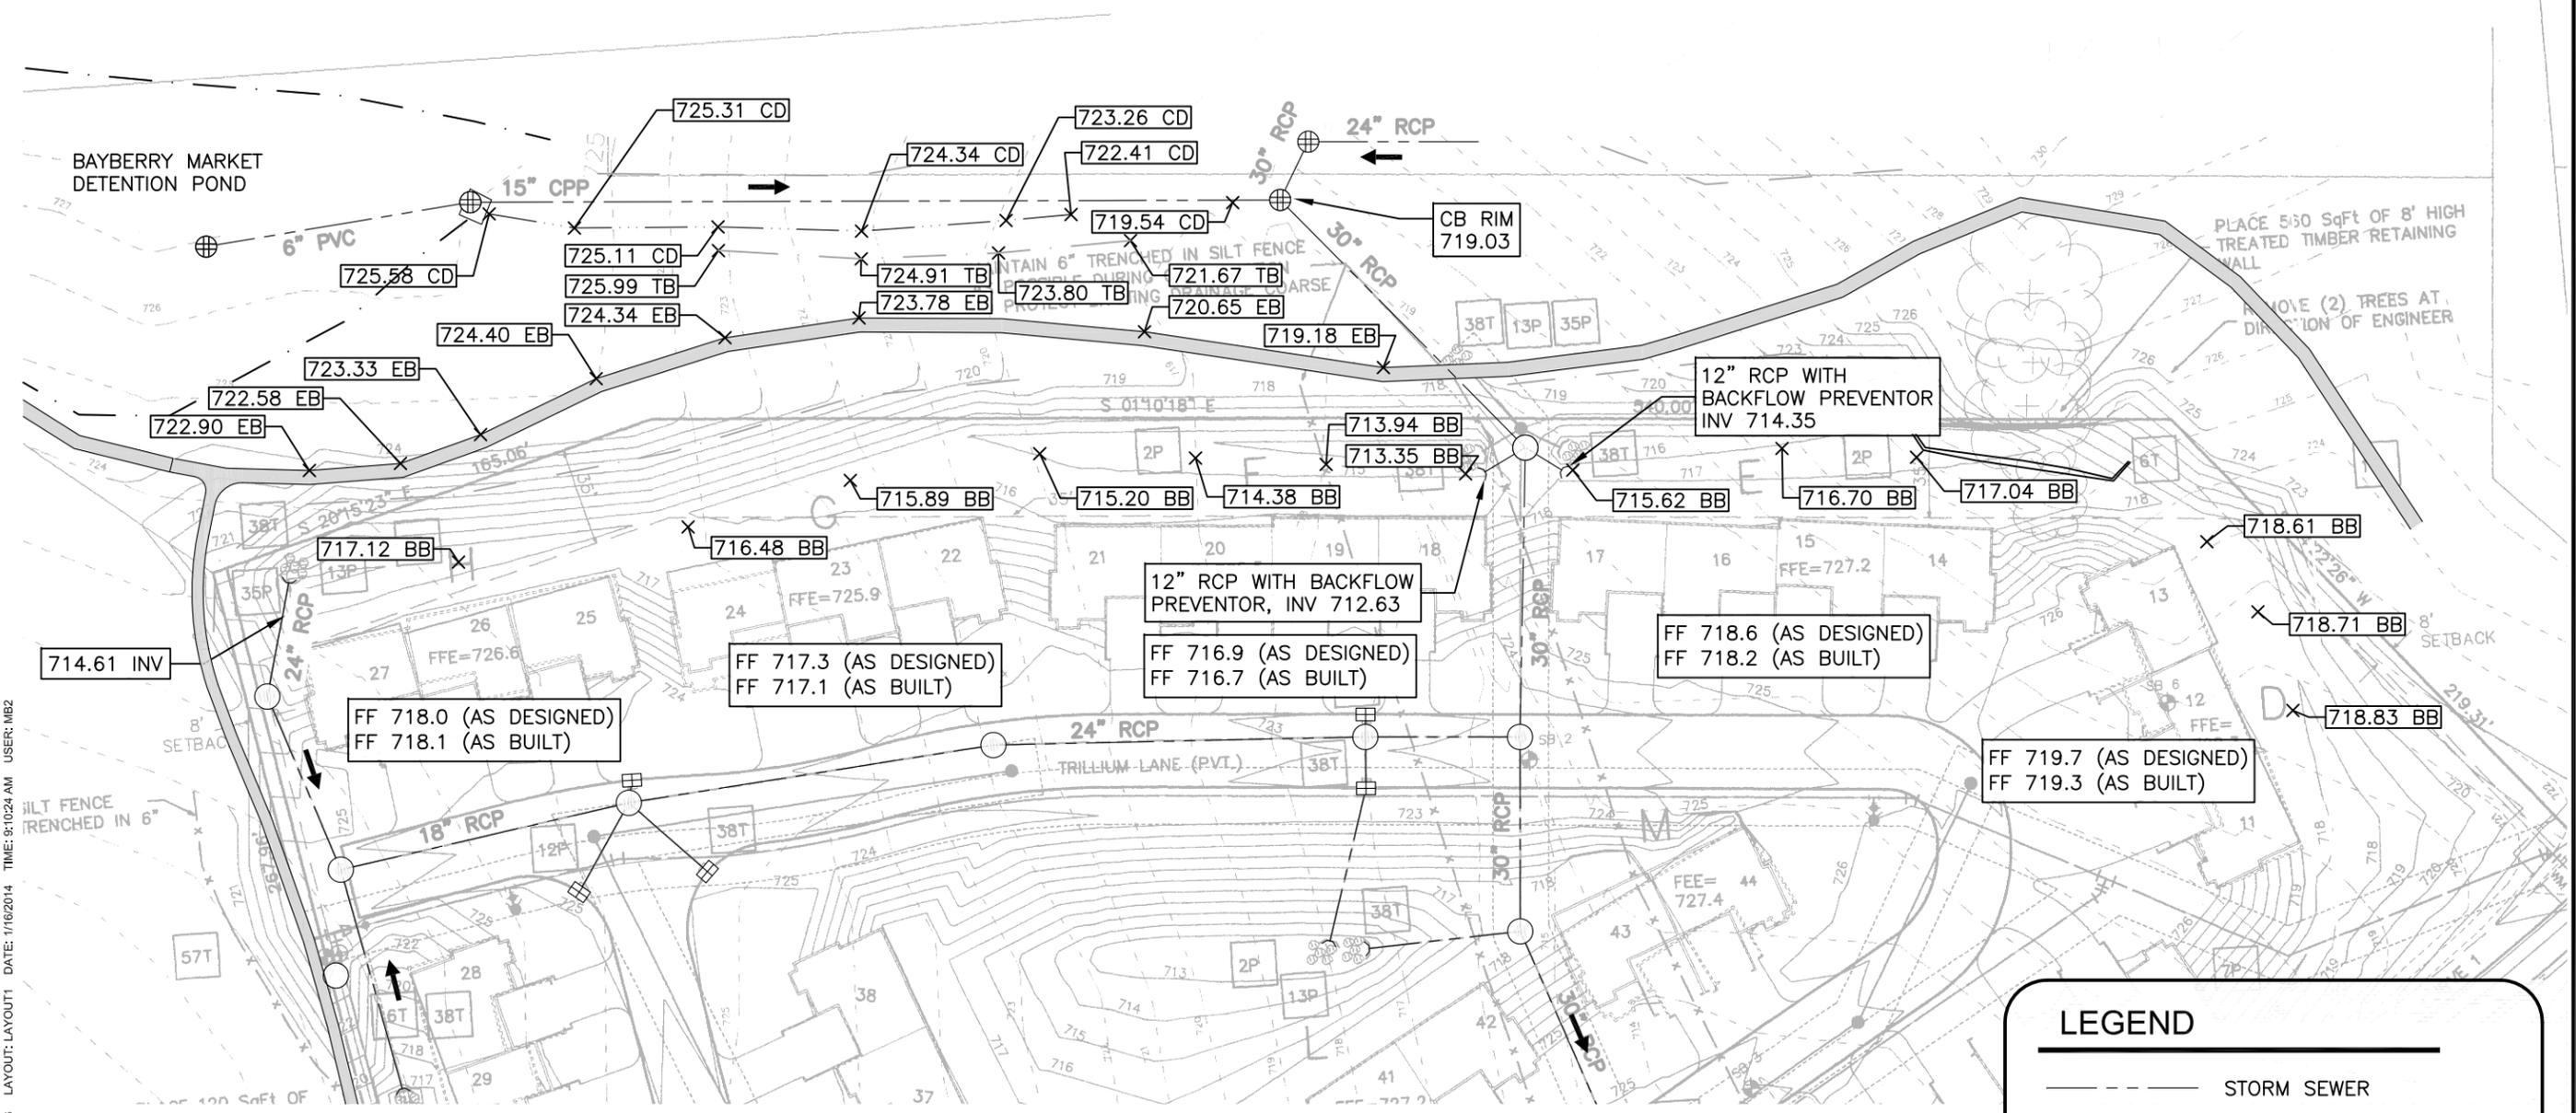
BAYBERRY FARMS CONDOMINIUMS
SCALE: 1" = 60'
0 30 60

The walk-out basements of the Condominiums are in a topographically low area without an available overland flow route. If the capacity of storm sewer inlets is exceeded and water ponds more than 3.5 feet, the walk-out basements will flood. A minimum of 1 foot of freeboard is provided between the 25-year design high water level in the swale and the lowest opening by City design standards. However, it appears the swale may have filled somewhat over time (noted during the as-built survey), which reduces storage capacity and can increase the risk of flooding. Analysis indicates overtopping of the Bayberry Market detention basin was the primary factor in flooding of the Condominiums. Additional information received by the Bayberry Condominium Board indicates the backflow preventers were not in place during the September 9, 2013 rain event, which may have exacerbated the extent of flooding.

The Bayberry Condominium Board should contract for the reinstallation of the backflow preventers removed during the spring of 2013. Tideflex check valves, or a similar product, to be approved by the City is recommended. The City should include this area as a critical location in their operation and maintenance plan.
